**MEETING DATE:** July 15, 2025  
**TO:** Mayor, City Council and City Administrator  
**FROM:** Ryan Ruzek, Public Works Director  
**SUBJECT:** Lake Augusta Improvements

# Lake Augusta Water Quality Improvement and Outlet Feasibility Study

Prepared for  
Lower Mississippi River Watershed Management Organization and  
City of Mendota Heights

December 2023

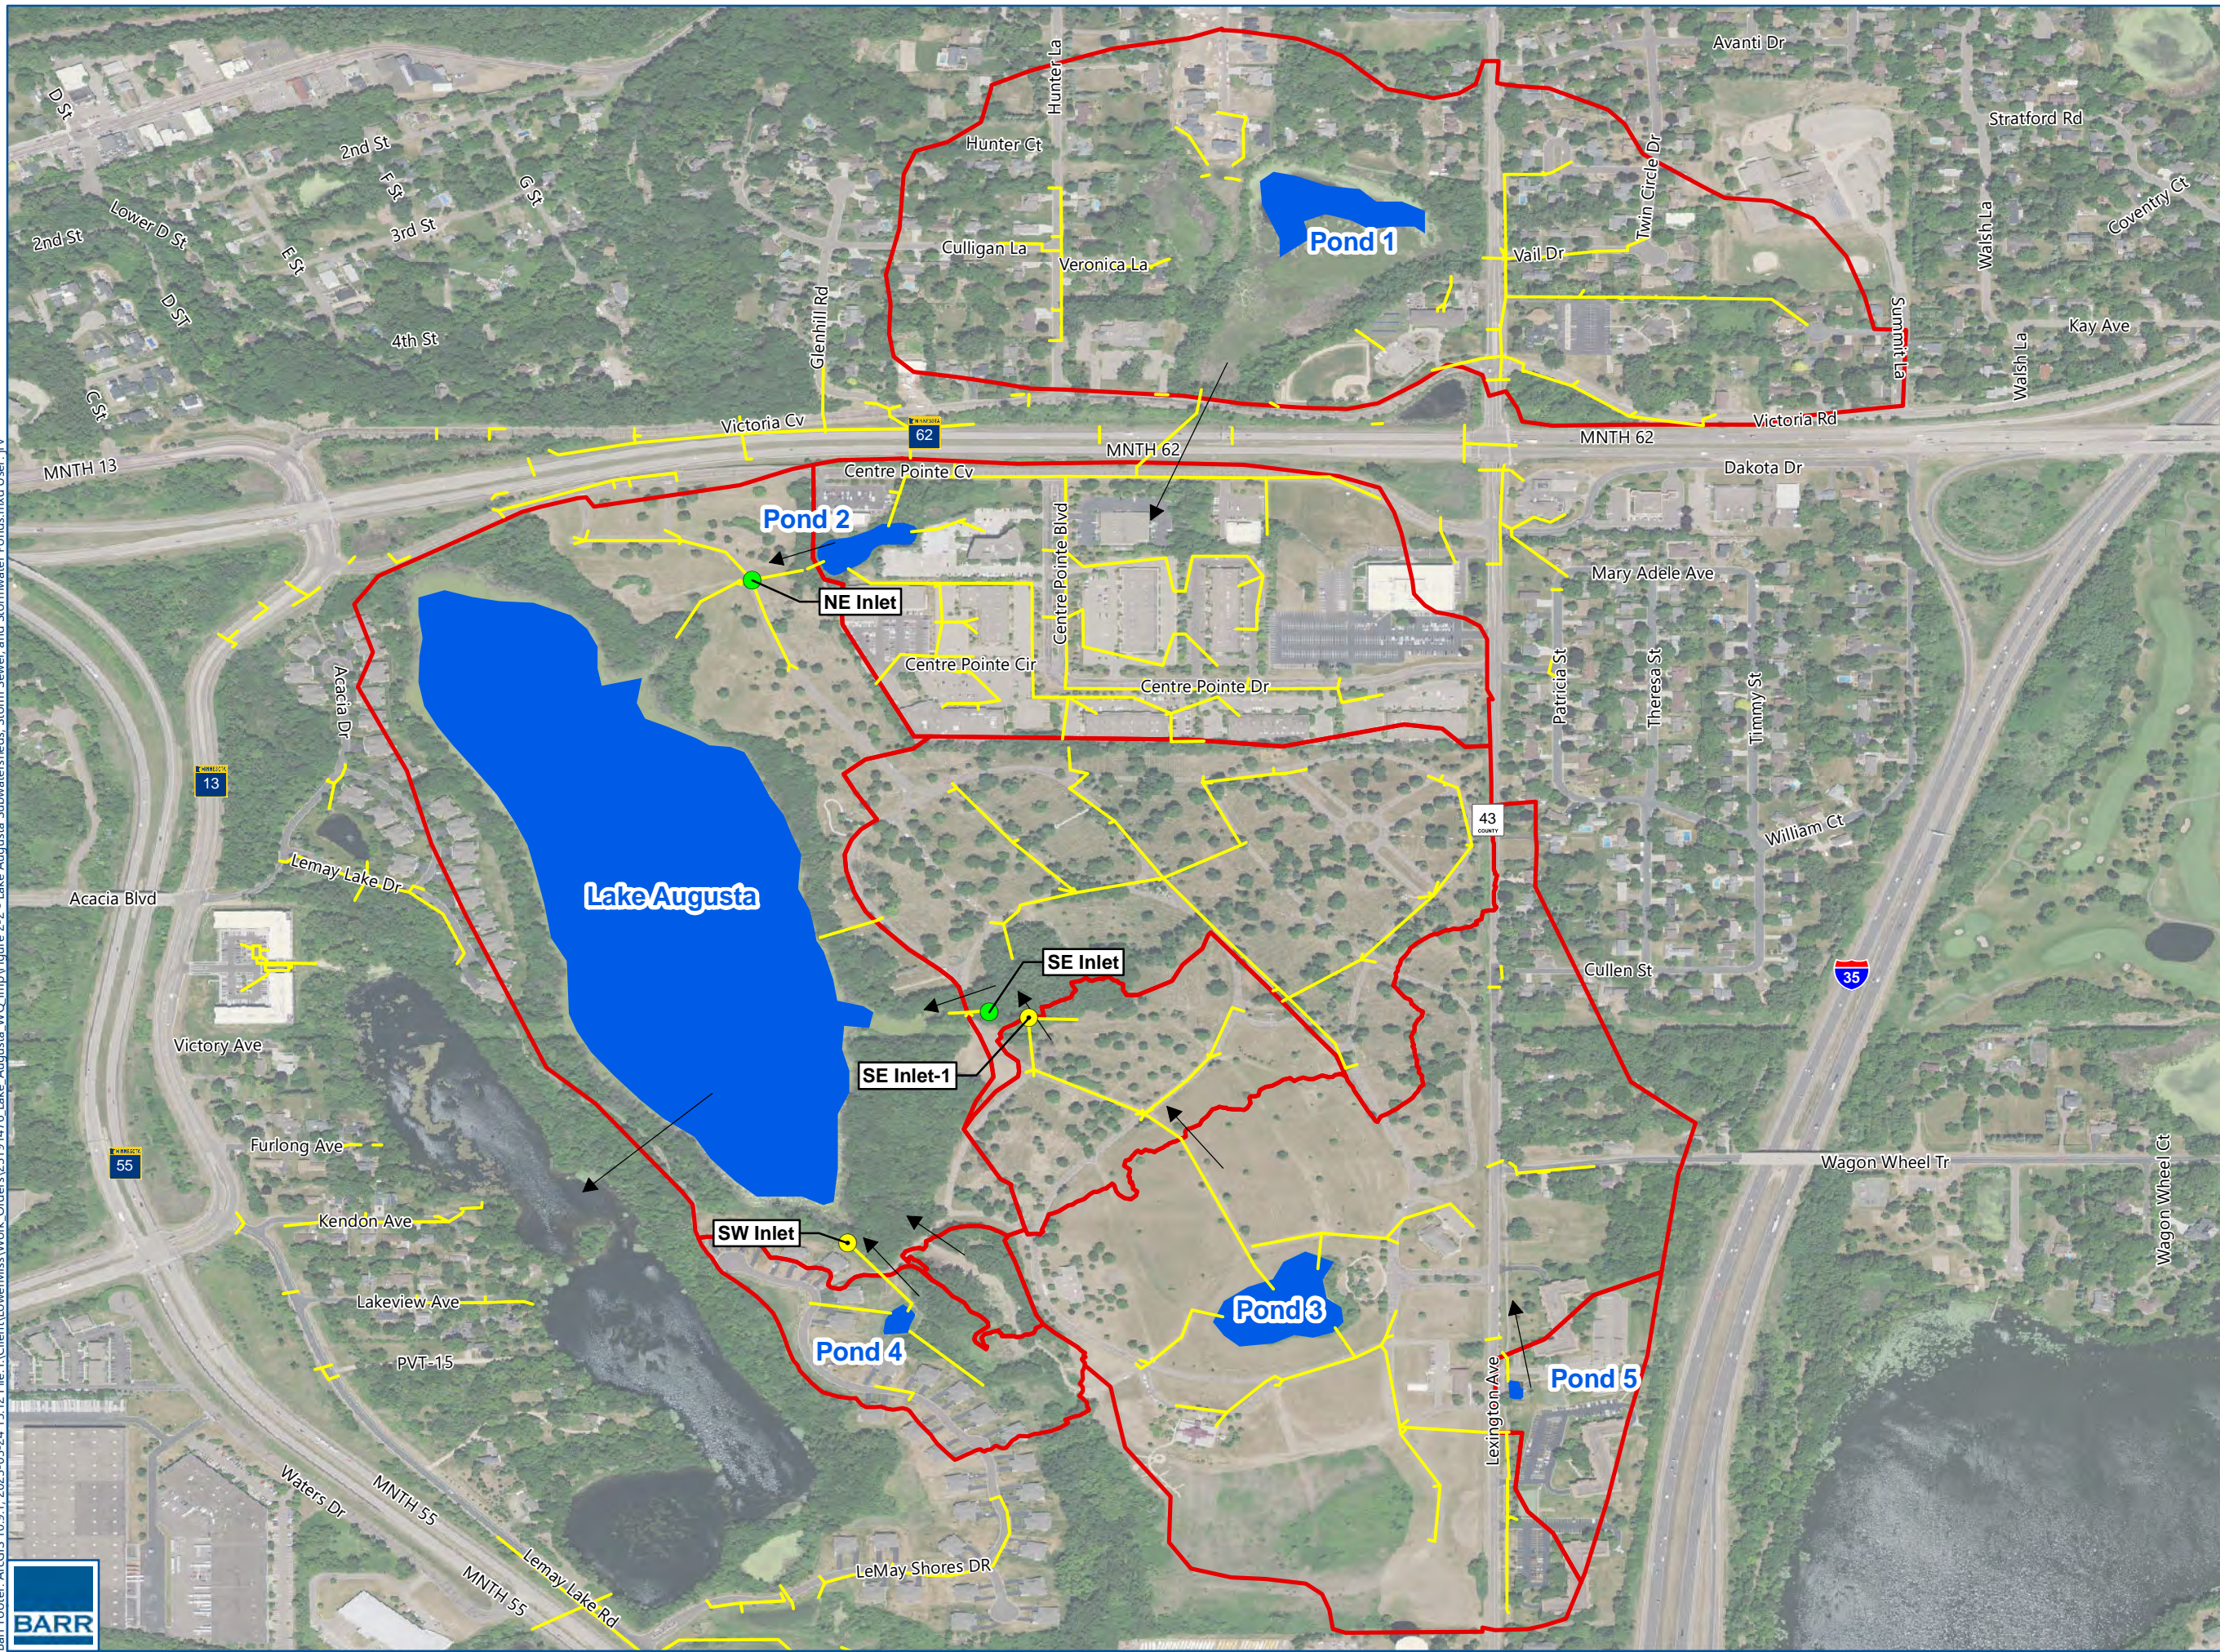
**FIGURE 2-2**

**LAKE AUGUSTA  
SUBWATERSHEDS, STORM  
SEWER AND  
STORMWATER PONDS**

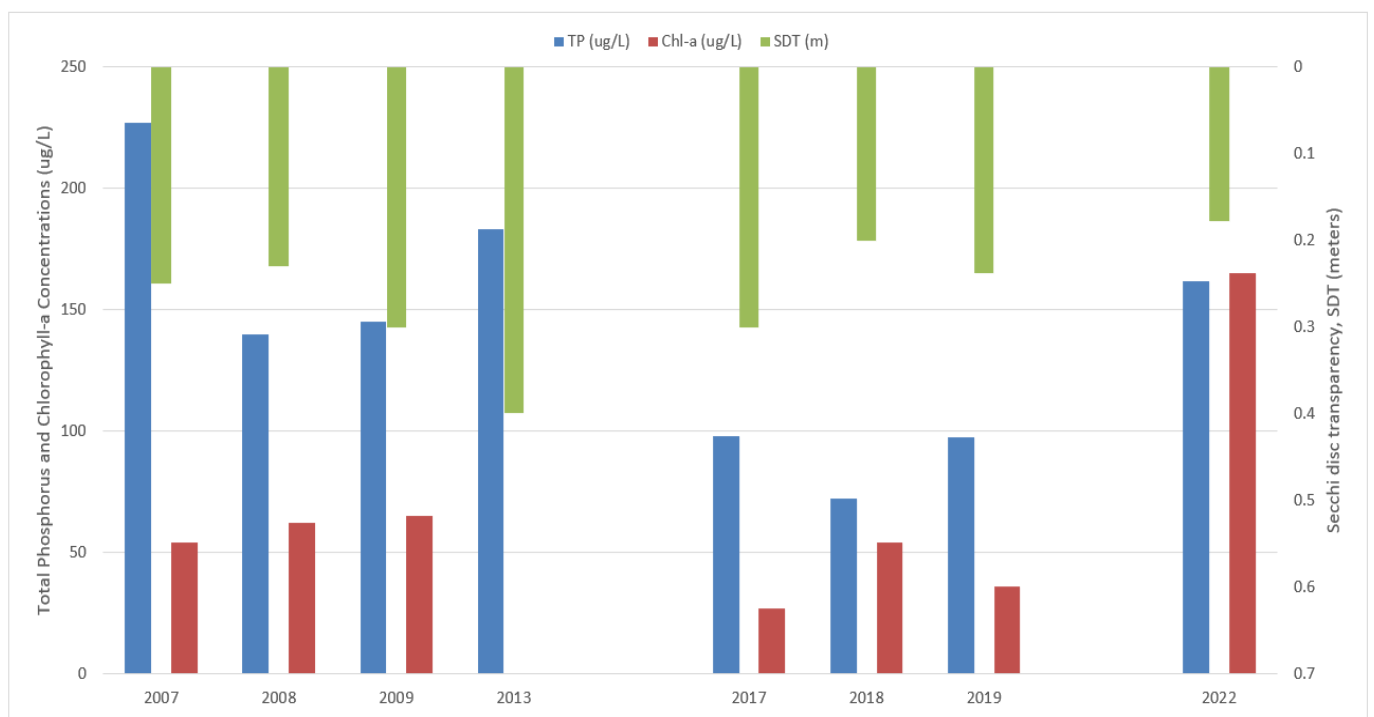
- 2022 surface water phosphorus concentrations are higher than the post-alum treatment monitoring events from 2017 through 2019, comparable to the pre-alum treatment monitoring.
- Chl-a levels were highest in 2022, compared to all the available monitoring data.
- Water clarity, measured as SDT, was lower in 2022 than any other year.

Figure 3-1 Lake Augusta Total Phosphorus, Chlorophyll-a, and Secchi Disc Transparency

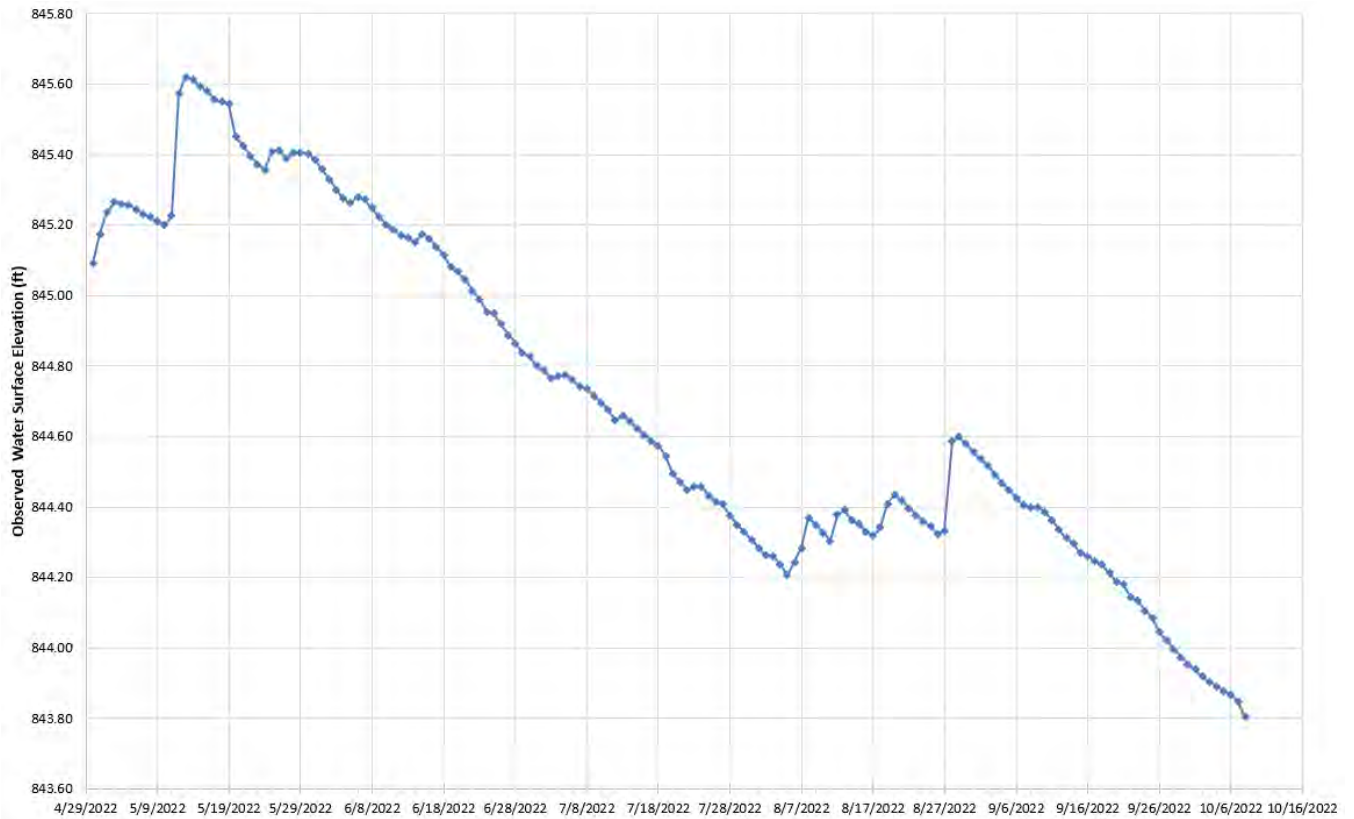
Figure 3-2 shows the monitored water levels for Lake Augusta during the 2022 monitoring season. The largest storm events during the monitoring period resulted in water level increases between 0.2 and 0.4 feet in Lake Augusta in the spring and later in the fall. Extremely dry conditions during June and July resulted in a lake level drop of approximately 1.2 feet.

Figure 3-2 2022 Lake Water Levels

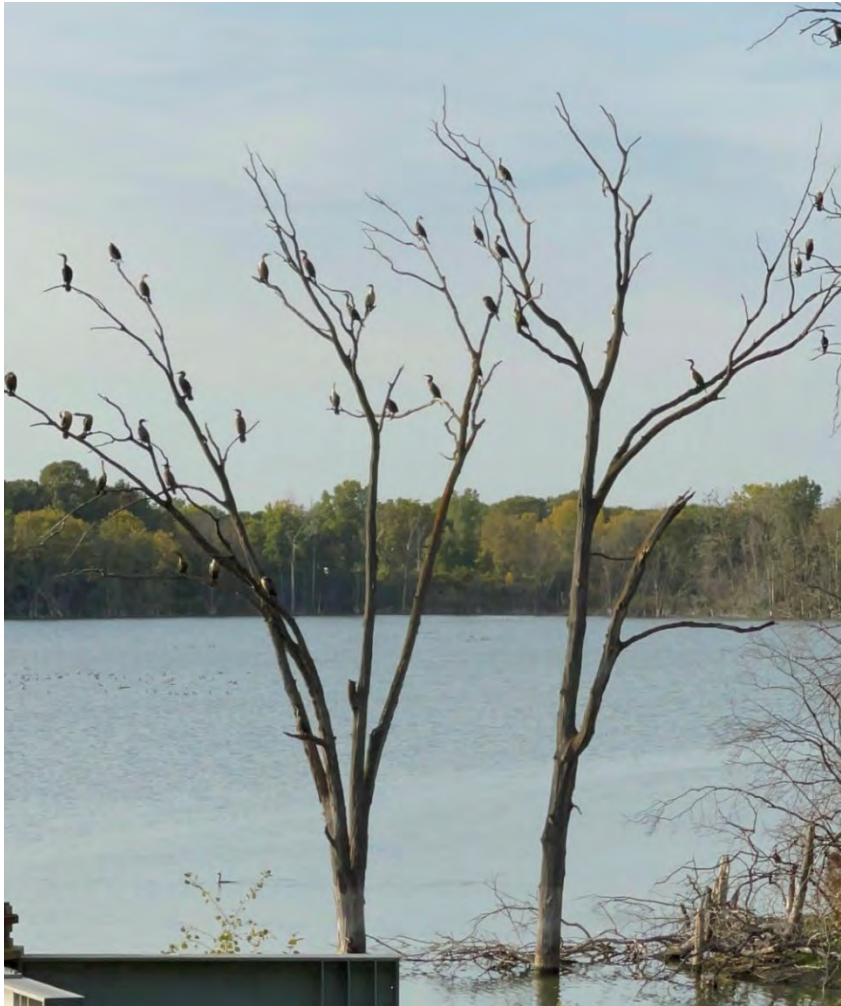
Figure 4-2 Cormorants Congregating on Dead Shoreline Trees

As previously noted, the landlocked condition of Lake Augusta has led to high lake levels that, in turn, have killed hundreds of the older growth trees that surround the lake shoreline as well as the forested understory. As shown in Figure 4-2, the dead trees are typically surrounded by lake water and are preferred habitat for large numbers of cormorants. Based on discussions with lake area residents, it was determined that fecal droppings from cormorants could represent another potentially significant source of TP load to Lake Augusta. Residents had compiled longer-term records about the number of birds and their daily patterns during the open water season. It was believed that many of the birds are fishing elsewhere during the day and returning to Lake Augusta during the evening and early morning hours. As a result, it is assumed that fecal matter from the birds represents a direct source of TP load to the lake that is derived from outside of the Lake Augusta watershed.

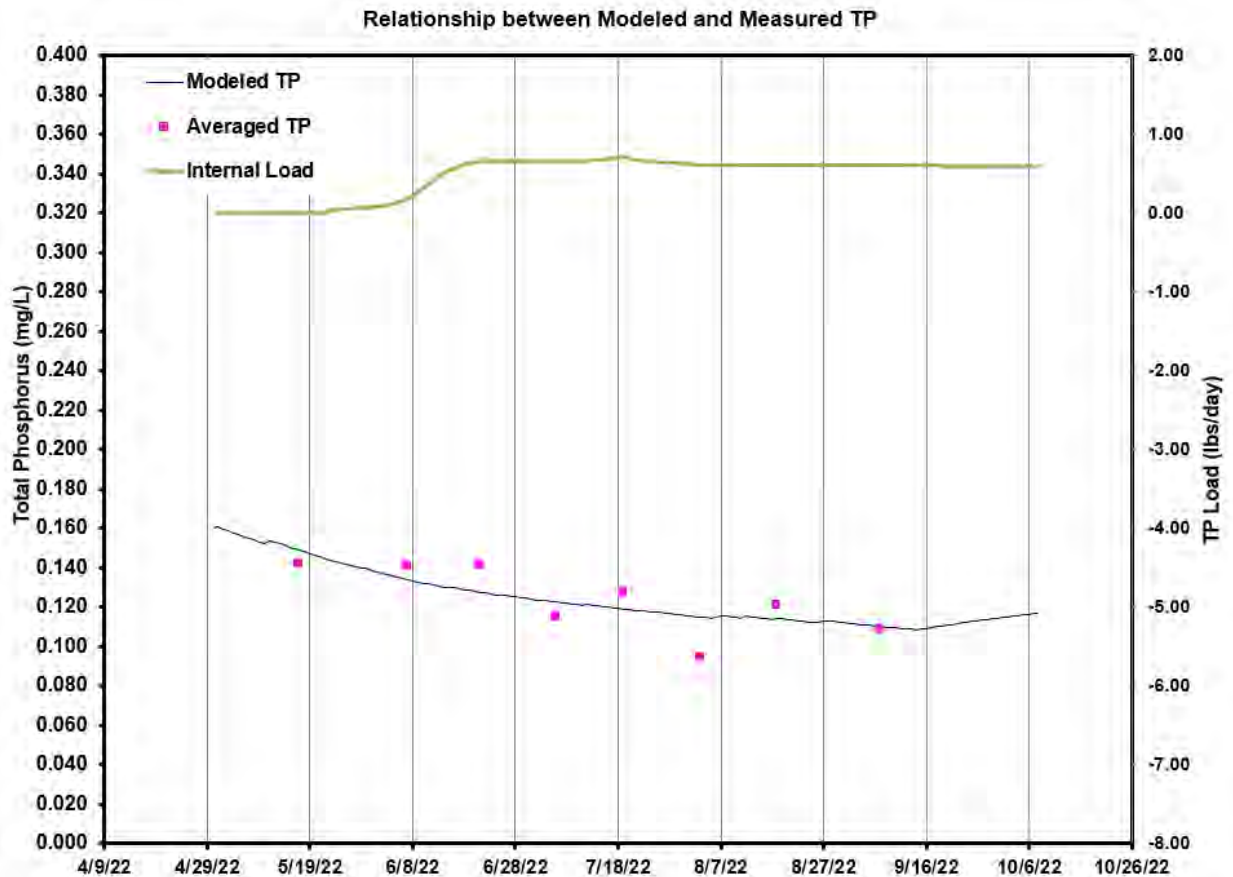
Figure 4-3 shows how the calibrated daily phosphorus mass balance simulation from the in-lake modeling agreed with the monitored lake phosphorus concentrations (expressed as a volume-averaged TP concentration), based on the calibrated P8 modeling inputs, along with the estimated internal phosphorus loading rate and TP load from bird droppings during the summer of 2022.

**Figure 4-3 Calibrated Water Quality Monitoring and Modeling Results**

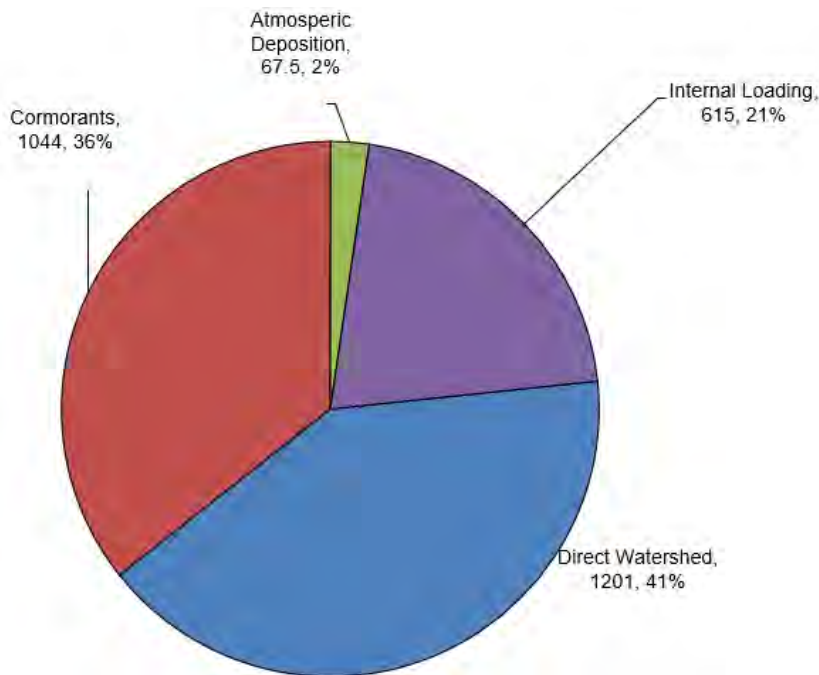
Following calibration, the P8 and in-lake modeling was run for the 2013 through 2022 water years to determine relative watershed and in-lake phosphorus loadings that are more representative of typical climatic conditions. Figure 4-5 shows that the cormorant droppings accounted for 36% of the phosphorus budget to Lake Augusta for the 2013 through 2022 simulation, with internal TP load (21%), watershed runoff (41%) and atmospheric deposition (2%) accounting for the remaining phosphorus inputs.

Figure 4-5 Modeled 2013-2022 Annual TP Sources (lbs,%) for Lake Augusta

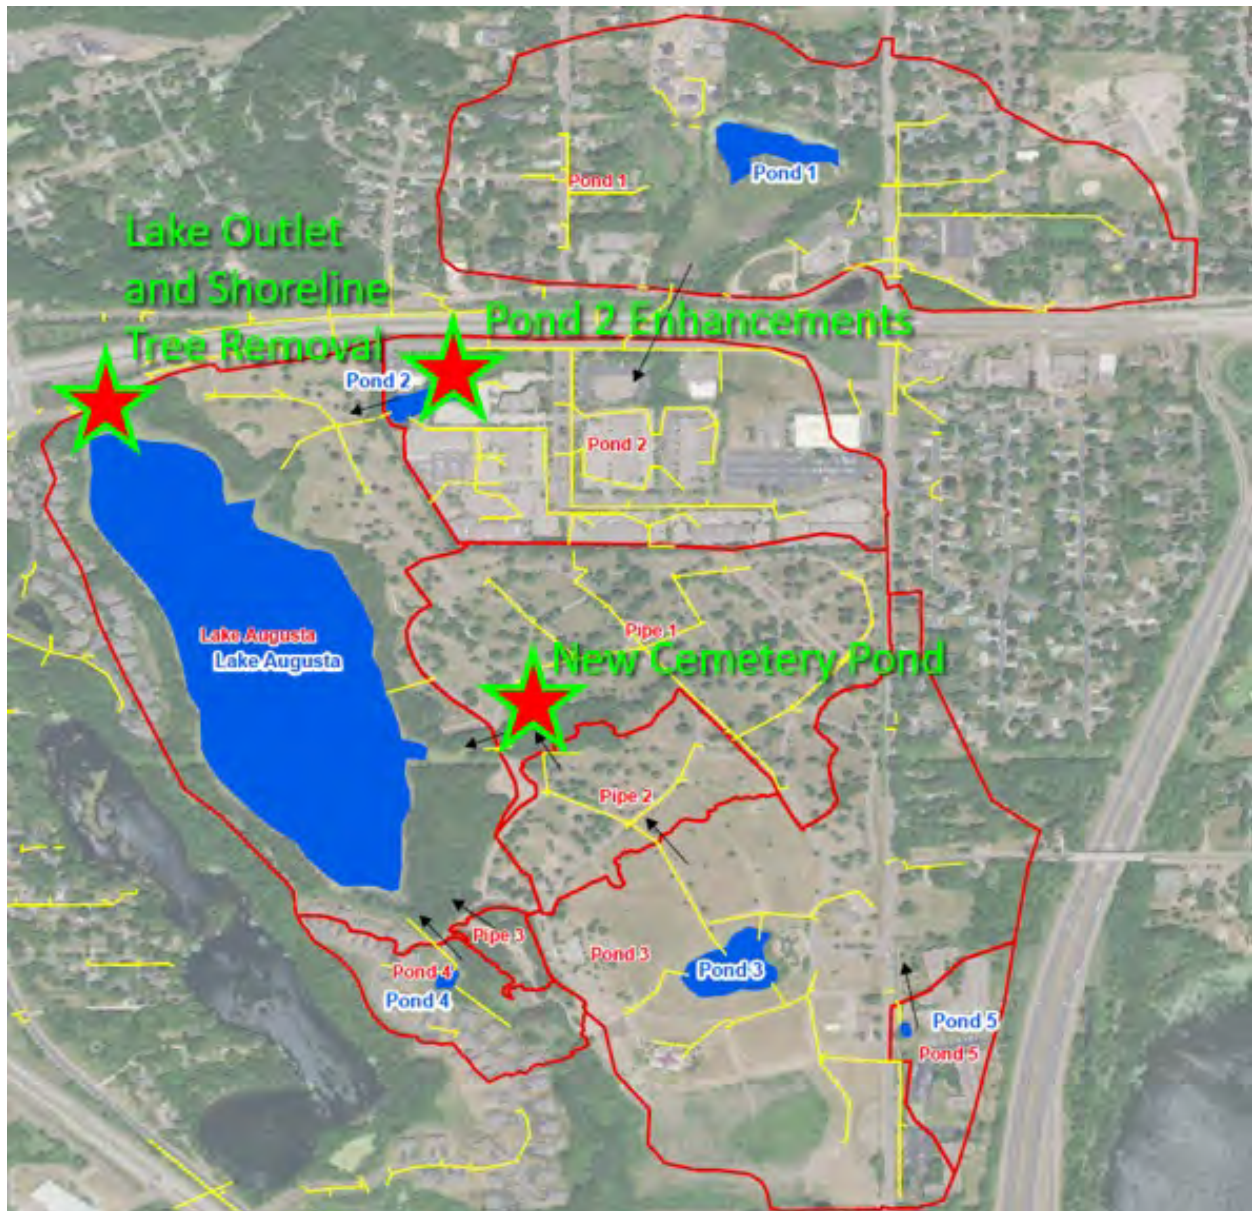
the direct watershed involve implementation of a lake outlet and removal of dead trees at the location shown in Figure 5-1.

Figure 5-1 Recommended Lake Augusta Subwatershed Locations for Structural BMPs

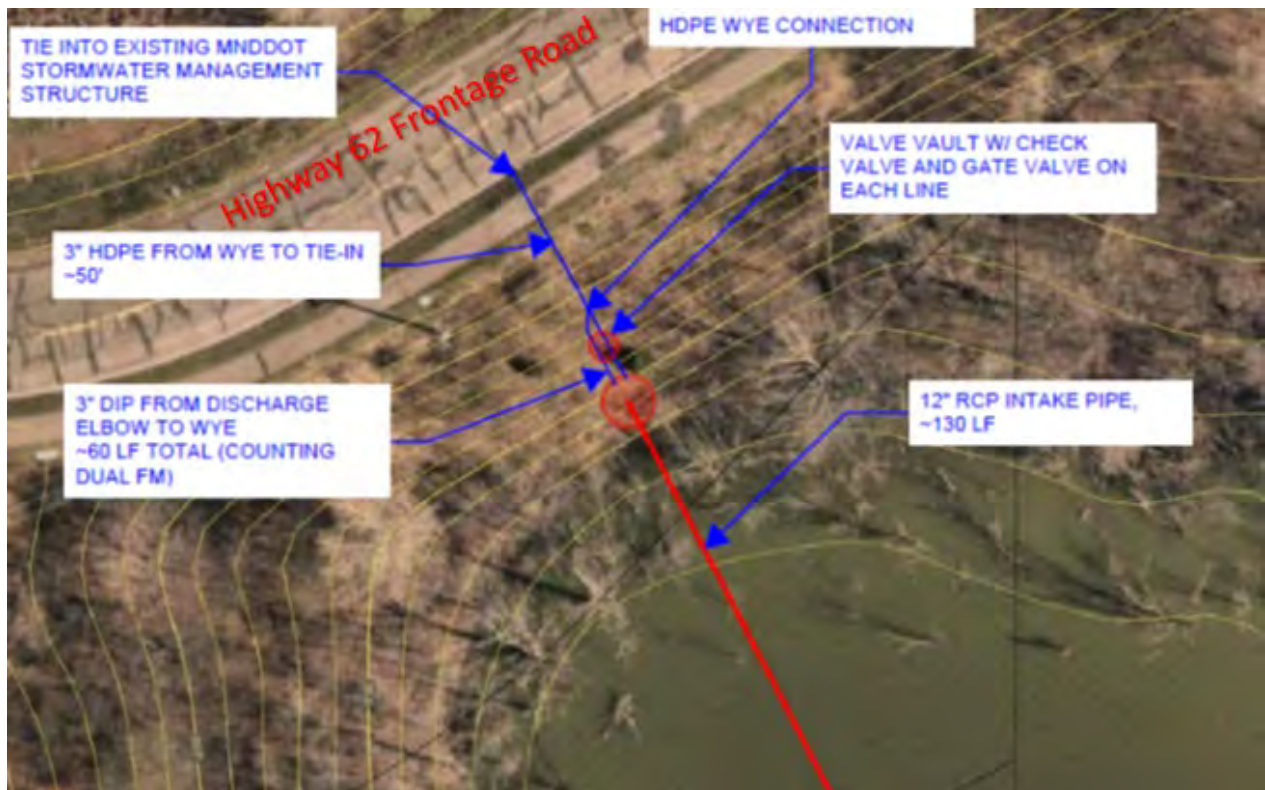
Figure 5-3 shows the proposed lake outlet conceptual design features, which include two 150 gpm submersible pumps (for redundancy, as noted above) with a wetwell and discharge piping to the closest frontage road catch basin. It is expected that the system would ordinarily be programmed to operate one pump at a maximum discharge rate of 150 gpm, but pump operation could be manually changed during high water conditions. The proposed intake pipe would extend far enough into Lake Augusta to allow for a drawdown that would facilitate the removal of the dead trees that surround the lake shoreline. Removal

Figure 5-3 Lake Outlet Conceptual Design

Appendix B includes separate planning level cost estimates for the lake outlet lift station and the tree removal. It is expected that the dead tree removal to discourage cormorant habitation could best be accomplished in the winter, following fall lake level drawdown, to facilitate better access to the larger dead trees from the lake ice. The cost estimate for shoreline tree removal includes (and assumes) the following level of effort:

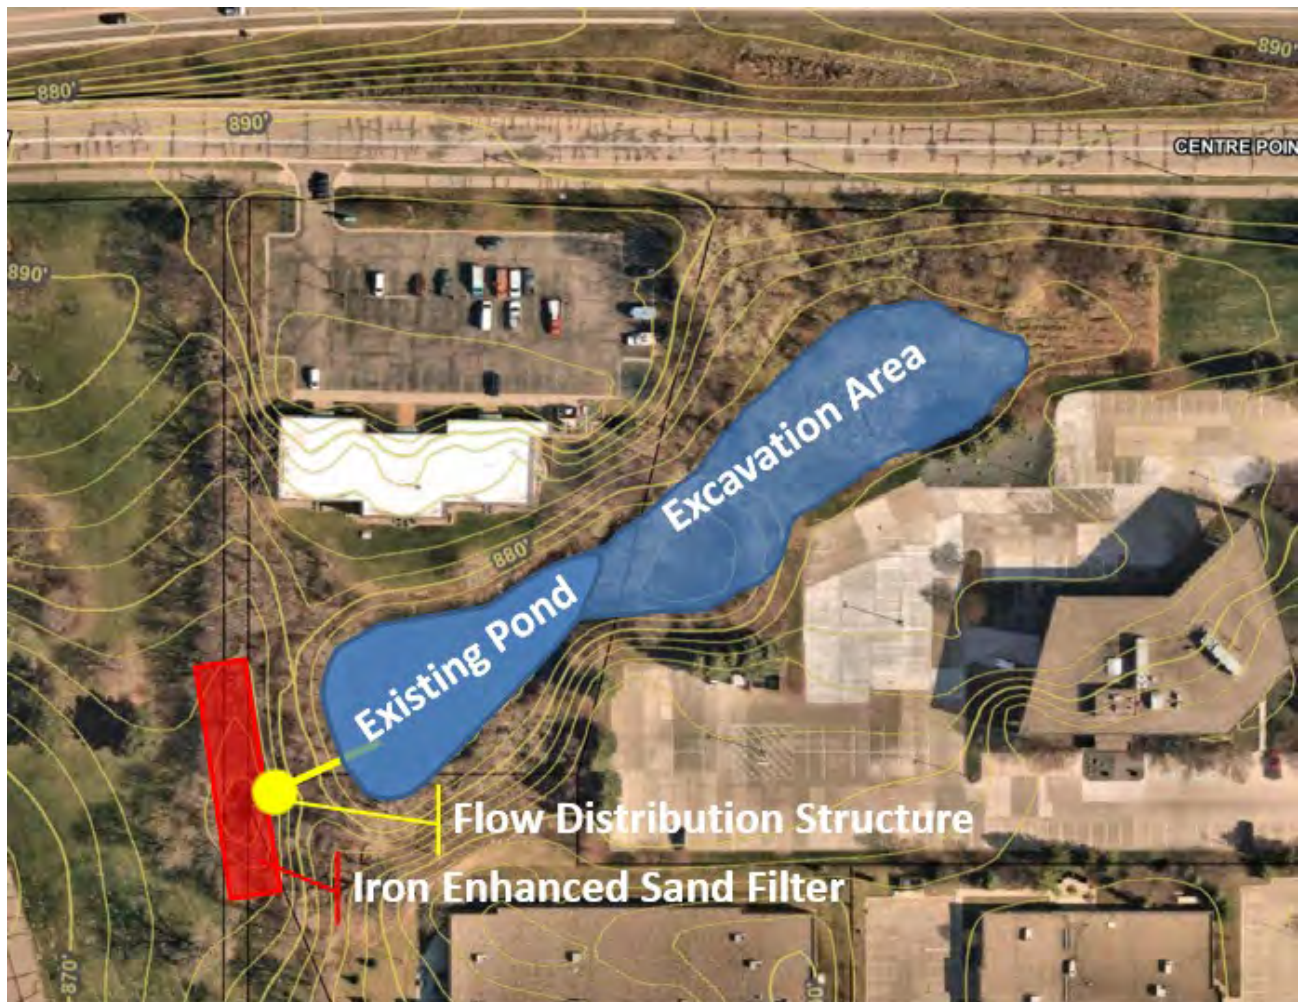
Figure 5-4 shows the conceptual design for enhancements to stormwater treatment at the Pond 2 site. Under current conditions, the calibrated long-term P8 model simulation estimates that Pond 2 is

removing 29% of the incoming TP load before discharge to Lake Augusta. The conceptual design includes significant expansion of the existing pond surface area and depth for improved particulate phosphorus removal, as well as an iron-enhanced sand filter to provide treatment of dissolved phosphorus from the pond effluent. The proposed pond surface area is twice as large as the existing area and the proposed dead storage volume is three times larger than current conditions. A TP load reduction of 17 pounds per year is estimated for the proposed condition, based on the long-term P8 model simulation. This pond is located on private property and would need close coordination with the property owners to implement improvements. Similar to the lake outlet, the expansion proposed for this improvement option will involve multiple landowners and future considerations for ongoing operation and maintenance, including drainage and access easements.

Figure 5-4 Conceptual Design of Stormwater Pond 2 Enhancements
